EMERGENCY AIRWORTHINESS DIRECTIVE

AD #: 2006-18-51

2006-18-51 RAYTHEON AIRCRAFT COMPANY (RAC): Directorate Identifier
2006-CE-48-AD.

Inspection Instructions – Raytheon Aircraft Company 1900 Series Wing Rear Spar

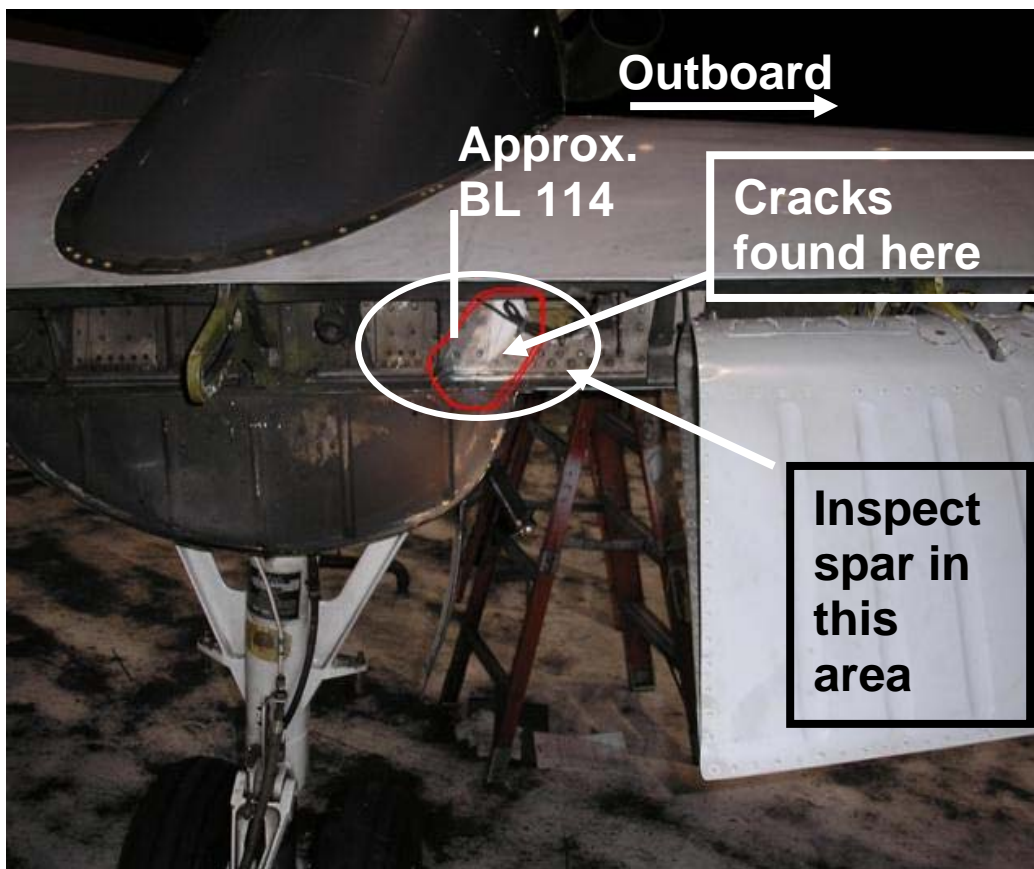
Step 2. Using a strong, high-intensity light visually inspect the area of the wing rear spar identified in Figure 1. There is ample visual access from above the upper surface of the flap. Look for cracks (like those shown in Figures 2 and 3) and loose or missing fasteners.

Figure 1: View of R/H wing rear spar at BL 114 area looking forward (The inboard flap is removed in this figure, but removal of the flap is not required to do the inspection).

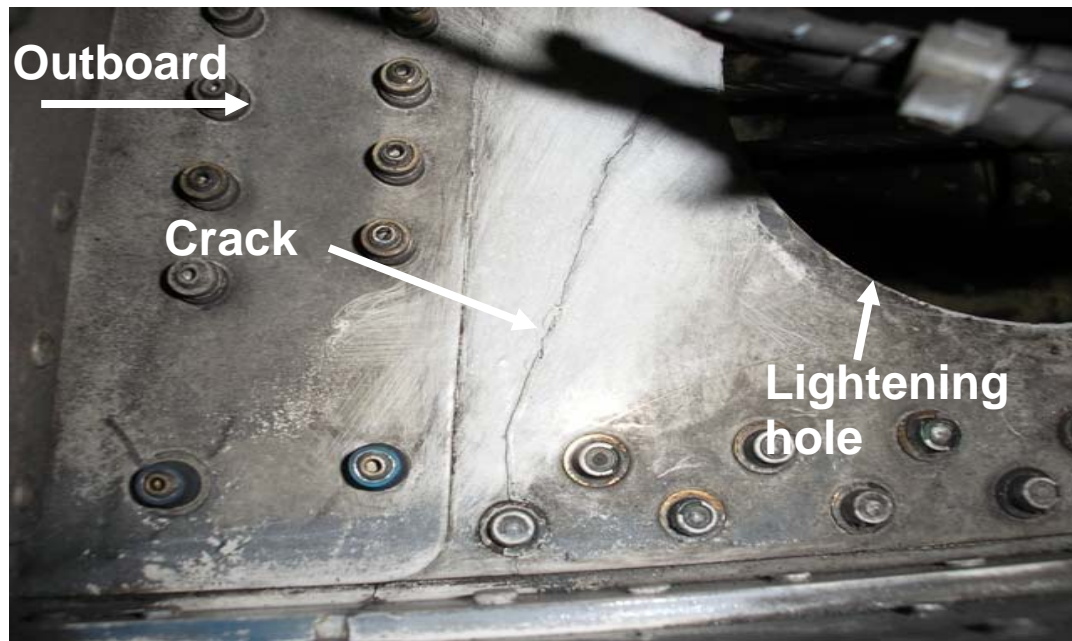
One airplane had 19,126 hours TIS when cracks were found. The cracks were in the lower aft spar cap flange, but the cracks extended upward into the web and terminated at the lightening hole in the spar web. Fasteners were also found missing in the spar cap and wing cove splice plate. There were no discrepancies recorded from the initial inspection at 17,500 hours TIS on this airplane.

Figure 2: Closeup view of R/H wing rear spar web crack at BL 114 area looking forward (The inboard flap is removed in this figure, but removal of the flap is not required to do the inspection).

(3) Repair any cracks or other damage such as loose or missing fasteners found during the inspection required in paragraph (e)(1) of this AD. Do this by obtaining and incorporating an FAA-approved repair scheme from RAC.	Before further flight after the inspection required by paragraph (e)(1) of this AD.	Contact RAC at Post Office Box 85, Wichita, Kansas 67201-0085; phone: 316-676-8366; fax: (316) 676-8745; email: tom_peay@rac.ray.com.

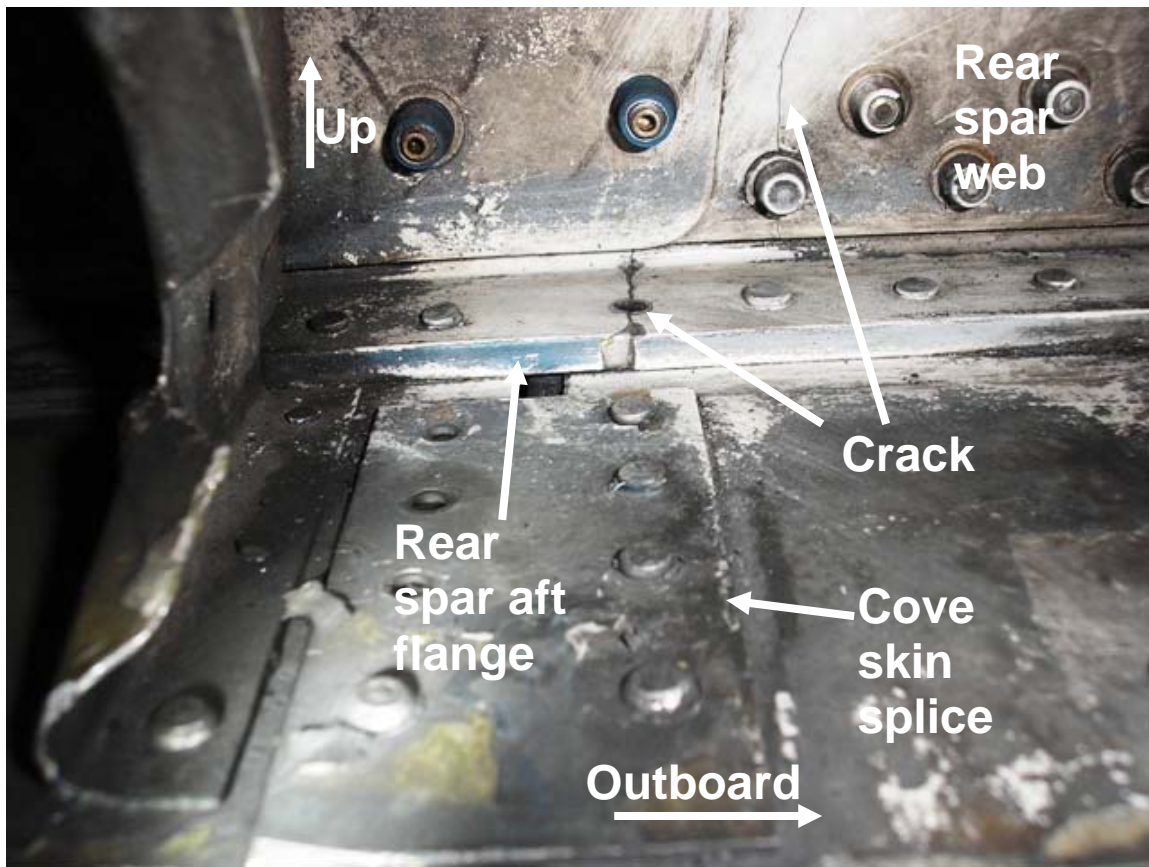
Figure 3: Closeup view of R/H wing rear spar cracks at BL 114 area looking forward (The inboard flap is removed in this figure, but removal of the flap is not required to do the inspection).
